Bilateral Post-Traumatic Skull Defect

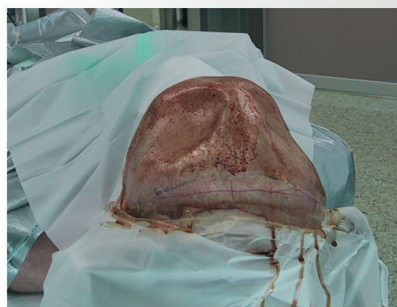
Bilateral Post-Traumatic Skull Defect
